THE USE OF TERRESTRIAL LASER SCANNING IN THE PRESERVATION OF VALUABLE ARCHITECTURAL OBJECTS

Izabela Piech, Przemysław Kłapa, Piotr Szatan

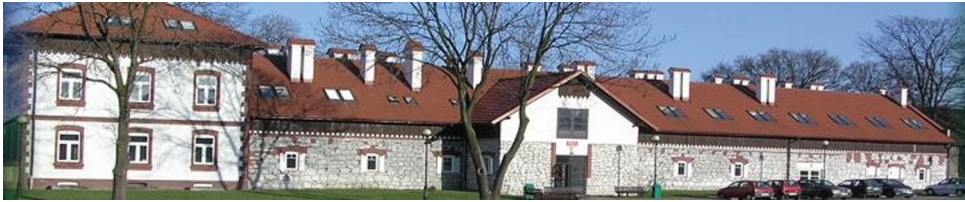
Fig. 1. Building belonging to the University of Agriculture in Krakow

In this work, a building located at the Hugo Kołłątaj University of Agriculture in Krakow at Balicka 253A was designated as the research object. The building currently has an educational function; it houses rooms in which practical classes are held, as well as storage space for research and teaching instruments. Inside the building, there are also rooms used for administrative purposes as well as offices of individual university employees. Historically, this building was part of a farm located in the area currently occupied by the Faculty of Environmental Engineering and Land Surveying. In all probability, it used to serve as a farm building, intended for the storage of grains and the breeding of livestock. Before the rights to the building were taken over by the Polish government, and consequently by the University of Agriculture, the area and all buildings were owned by Adolf I Czesław Schoen, who purchased the property in 1880 [Fedor 2013]. The building is rectangular in shape and has two storeys. It is built of large stone blocks, which means that it has very thick walls and very narrow and small windows. The roof is covered with ceramic tiles. The façade is white, covered with plaster. The windows are not original;

they were probably replaced during renovation works, and more windows were added to the roof surface, which would not have matched the original purpose of the building. On the right, there is a three-storey extension, which was built later, as can be inferred from a different building style and the use of different materials. A characteristic element that does not match the original purpose of the building is a balcony connected to the vestibule. It is worth mentioning the decorative, wooden elements under the thatched roof. To sum up, despite being adapted to its current function, the studied building has retained structural elements that are worth preserving and documenting (Fig. 1).

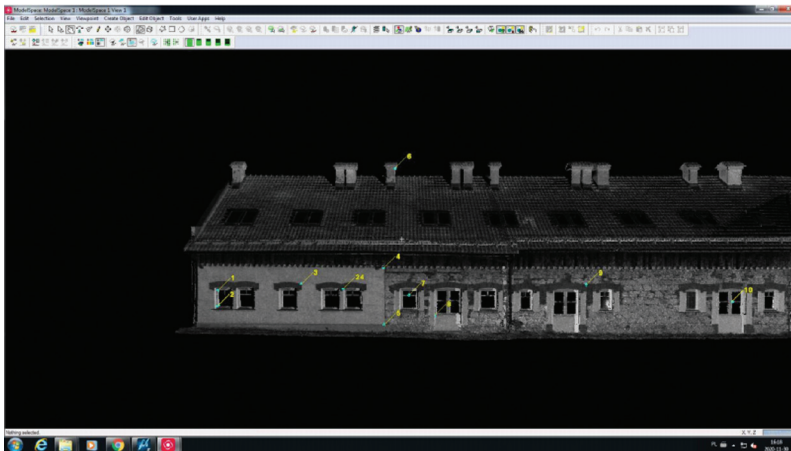
Fig. 2. Placement of the vertices in the left part of the building

be performed included, primarily, combining the point clouds from individual stations into one collective cloud. Having combined the data, we proceeded to identify any measurement distortions, and to determine which scanned elements do not belong to the studied building object. Then all the points that were not designated for further processing had been deleted. The Leica Cyclone software was used to perform these activities. The first task to perform was to create a database with the 'add database' command, and import data from all of the measurement stations. The next step was to orient the point clouds in relation to each other, and combine them into one collective point cloud that would represent the shape of the building object that was subjected to the measurement. Characteristic elements of the building, measured from both stations and clearly identified, had been used to combine the data from individual stations. This amalgamation was possible thanks to the use of the Vertex function. The arrangement of individual vertices on the building's elements is shown in Figures 2, 3 and 4.

In order to maintain the required level of accuracy, 24 vertices had been defined, and their distribution was planned and executed in such a way that there was only one vertex on one vertical and horizontal plane. These activities had a key impact on obtaining the level of orientation error that had been assumed in the project, that is, not exceeding 0.05 metres (Table 1).

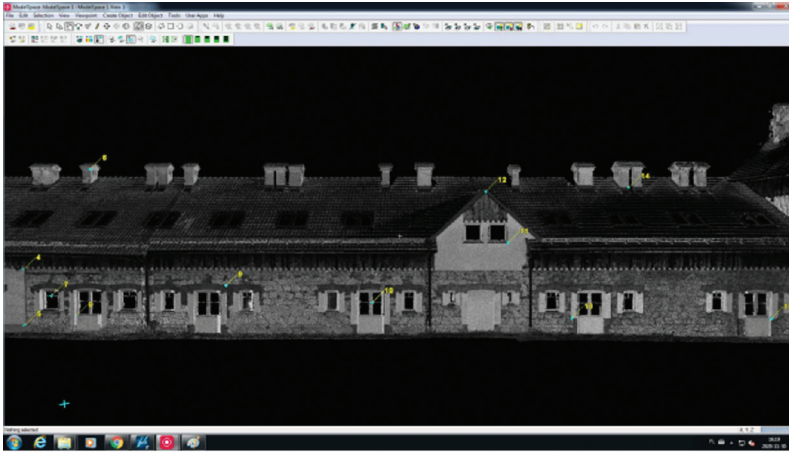
Fig. 3. Placement of the vertices in the central part of the building

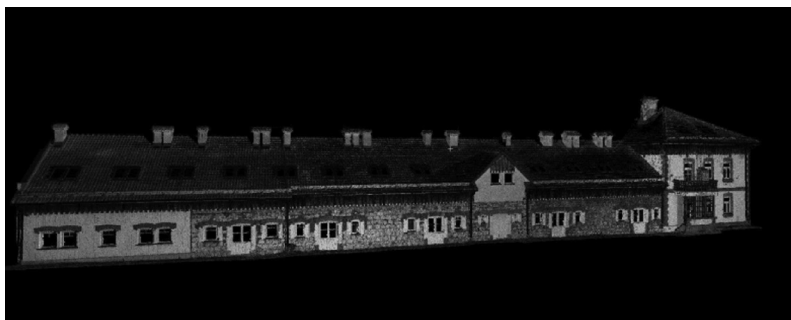
Fig. 5. Edited (adjusted) point cloud

Having combined the point clouds from individual stations and having executed the orientation process, we were able to proceed to the next activity, which was removing elements that do not constitute the object of the measurement. The result thus produced was a point cloud showing only those elements that would be subject to further processing. In this particular case, the obtained effect is a cloud of points representing the elevation and the roof of the object under study (Fig. 5).

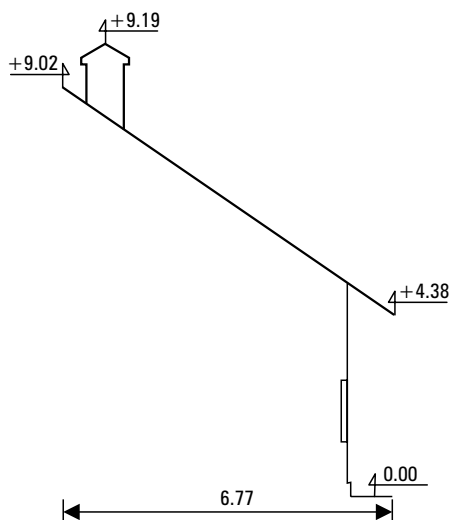
Fig. 6. Side projection of the building at Balicka 253a, from the left

In order to facilitate work while uploading, the function of selecting and dragging a point cloud has been enabled. This significantly accelerated the work on the project, as the drawn lines did not interact with the cloud. Thanks to the described methods and tools for creating views, drawings were made showing the building's elevation and projections (Figs 6, 6a, 7, and 8), which represent individual fragments of the building.

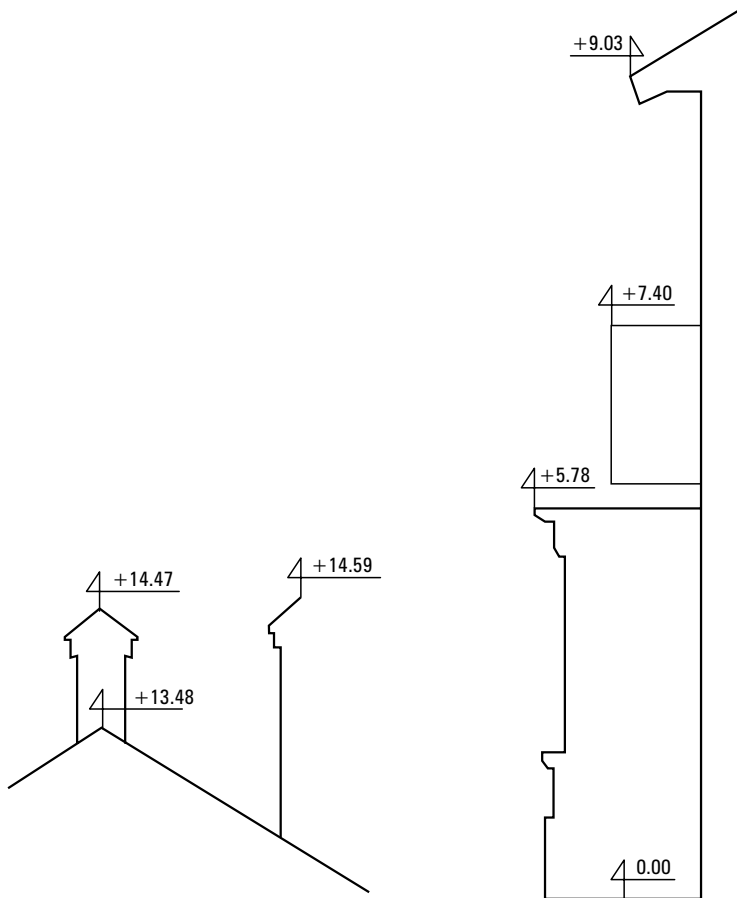
Fig. 6a. An enlarged fragment of the side projection of the building at Balicka 253a

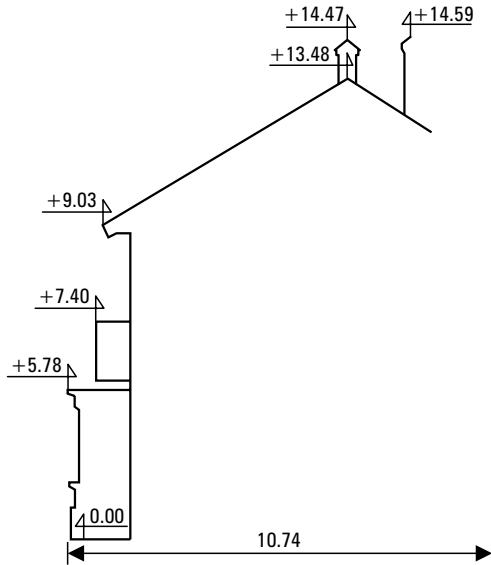
Fig. 7. Side projection of the building at Balicka 253a, from the right

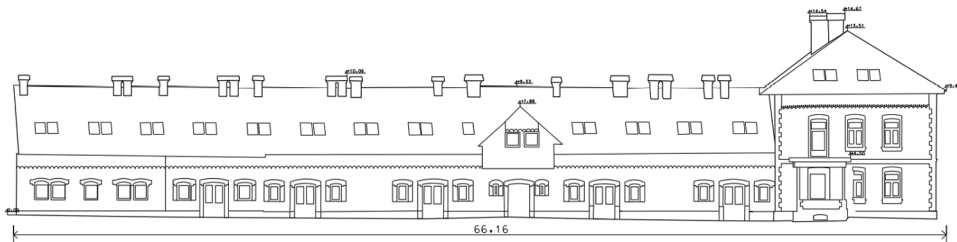
Fig. 8. Elevation of the building at Balicka 253a

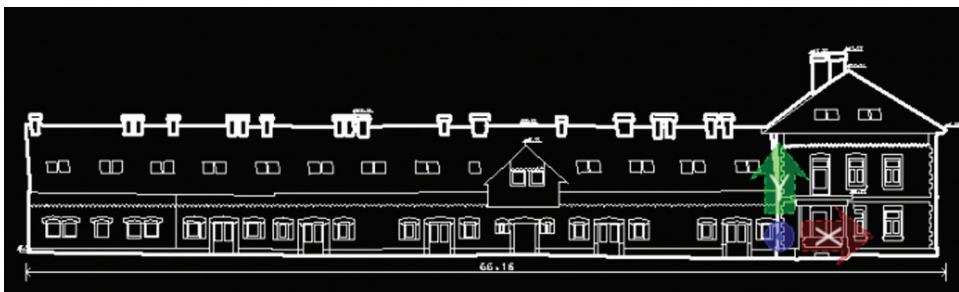
Fig. 9. Drawn contour lines of the elevation view

After all the elements had been drawn, the drawings were measured with the 'Measure Distance' tool. The obtained measures correspond to the actual dimensions, because the cloud representing the object under development had been displayed on a 1:1 scale throughout the process. Then, all the measured elements were described with corresponding measures. As a result, documentation was created that represented the appearance, shape, and size of the studied object and its elements (Fig. 9).

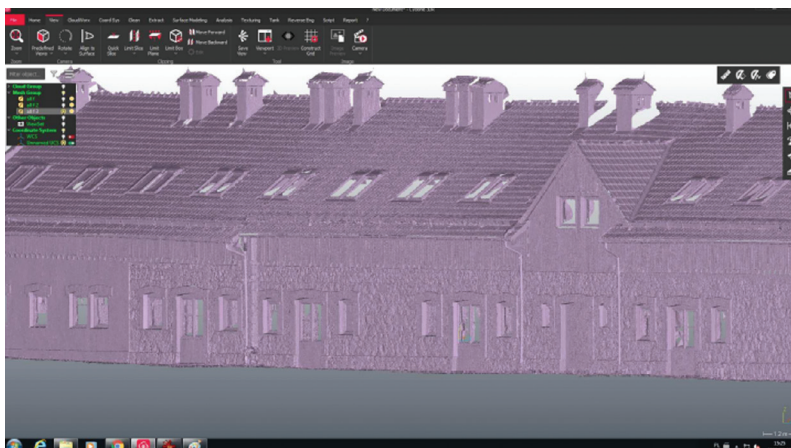
Fig. 11. Mesh representing a fragment of the elevation

End result of the discussed process is the creation of a mesh that can be further processed or used as a material illustrating the details of the measured objects (Fig. 11).
