Assessing the health conditions of residential allotments

This study presents an assessment of the health conditions of residential allotment in El-Eulma city, Algeria, using a case study framework. Its aim is to identify the indicators affecting human physiological comfort in the environment of residential housing. The study was carried out in two phases. The first phase was conducted on site, revealing that the residential allotment underwent both horizontal and vertical densification, horizontally, nearly half of the initial plots were subdivided into smaller parcels, vertically, building heights were increased, furthermore, the strictly residential function was transformed into a mixed function, incorporating commercial spaces on most ground floors. The second phase involved a simulation generated by the ArcGis10.4 software to assess the health conditions on three levels: the first level included a multi-criteria analysis, which made it possible to identify adverse health conditions of the building; the second level involved a shading tool, which allowed to detect the zones with external adverse influence on health conditions, and finally, the third level was the evaluation of

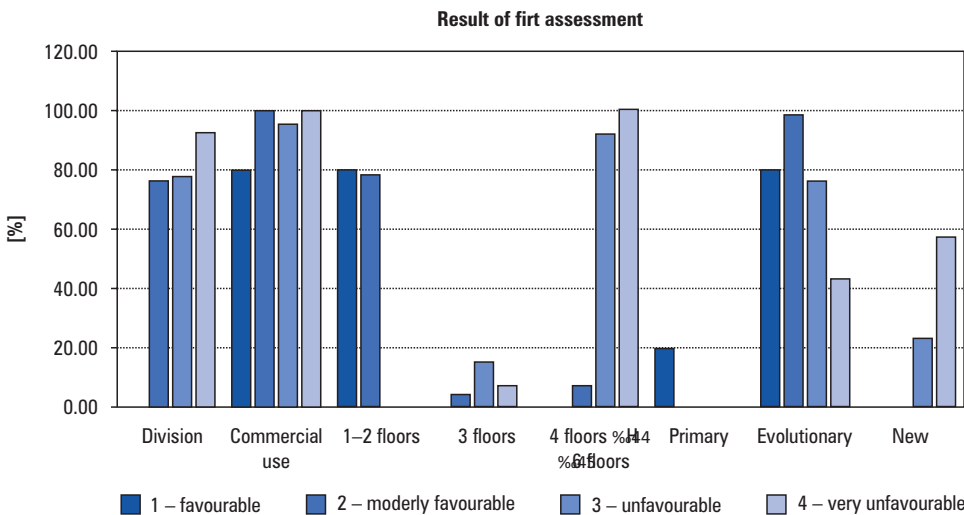
Fig. 10. Classification of buildings into four categories, from ‘favourable’ to ‘very unfavourable’

As Figure 10 presents, this step allowed us to determine the adverse health effects that are endogenous to the building, whether affecting the entirety of the building or only its part. The findings revealed that buildings created after plot subdivisions, with

a height exceeding GF+3 and commercial use on one or more floors, were predominantly classified as ‘very unfavorable’, accounting for 21.15% of the total. Additionally, after including the ‘unfavorable’ dwellings, which constituted 34.53%, a total of 55.68% of the monitored housing units experienced a deterioration of health conditions. It is noteworthy that the majority of new buildings were classified as ‘very unfavorable’. Exceptions were observed for buildings that did not exceed GF+2.
